PHENIX WEEKLY PLANNING

Aug. 1, 2013
Don Lynch

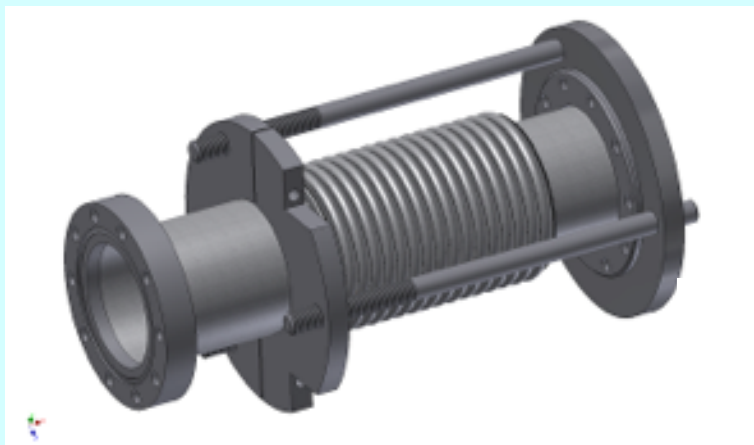
Existing vacuum bellows anti-squirm In MPC S Cavity

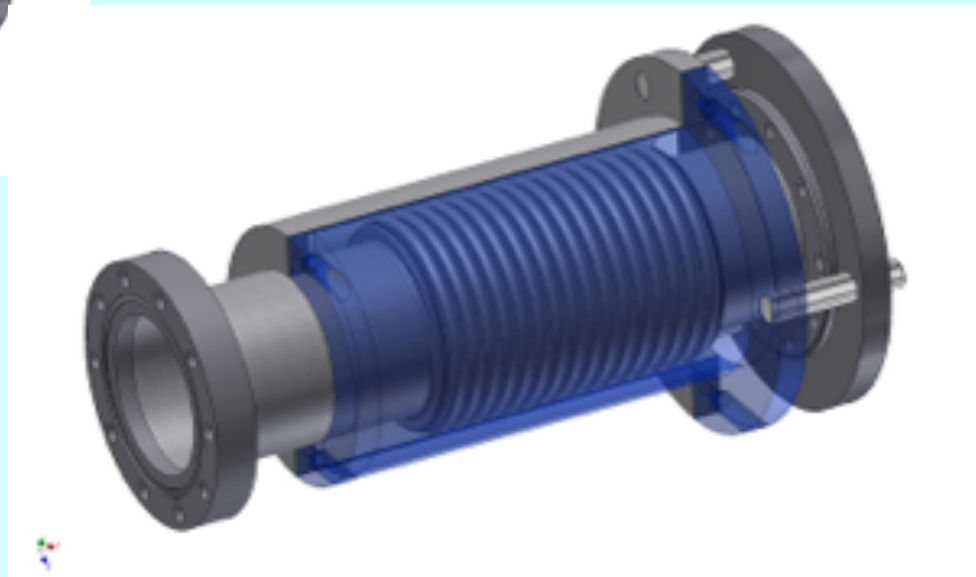
Design vacuum bellows anti-squirm in MPC S Cavity to accommodate MPC-Ex. Parts now at CS for fabrication

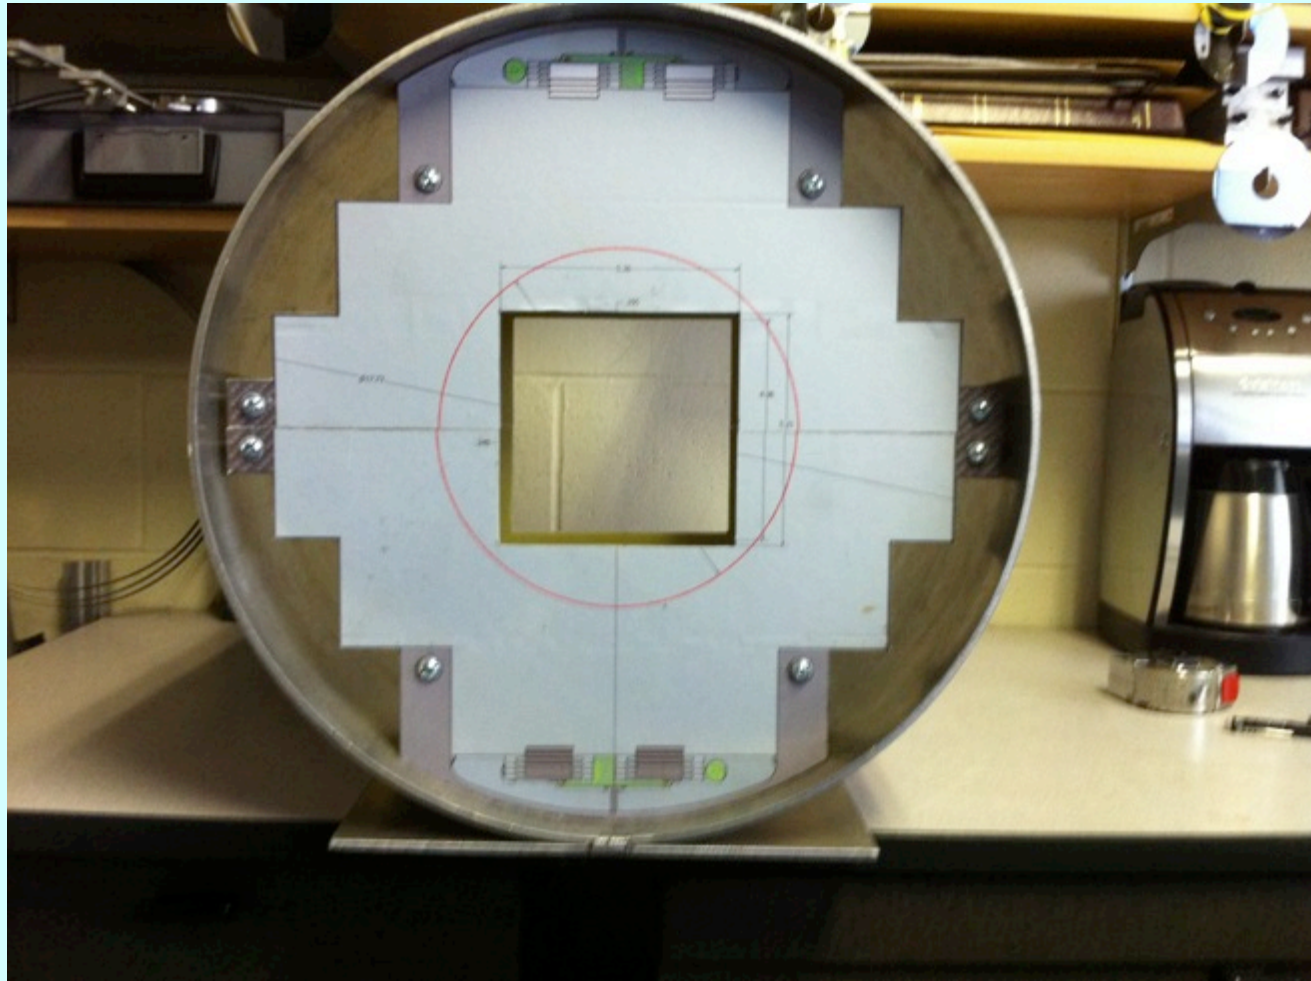
MPC-Ex mockup to be used for cable and utilities routing plans

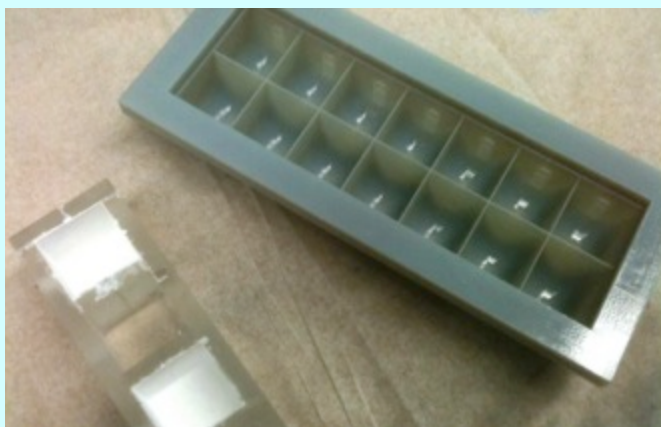
Prototype "Egg Carton" light collection

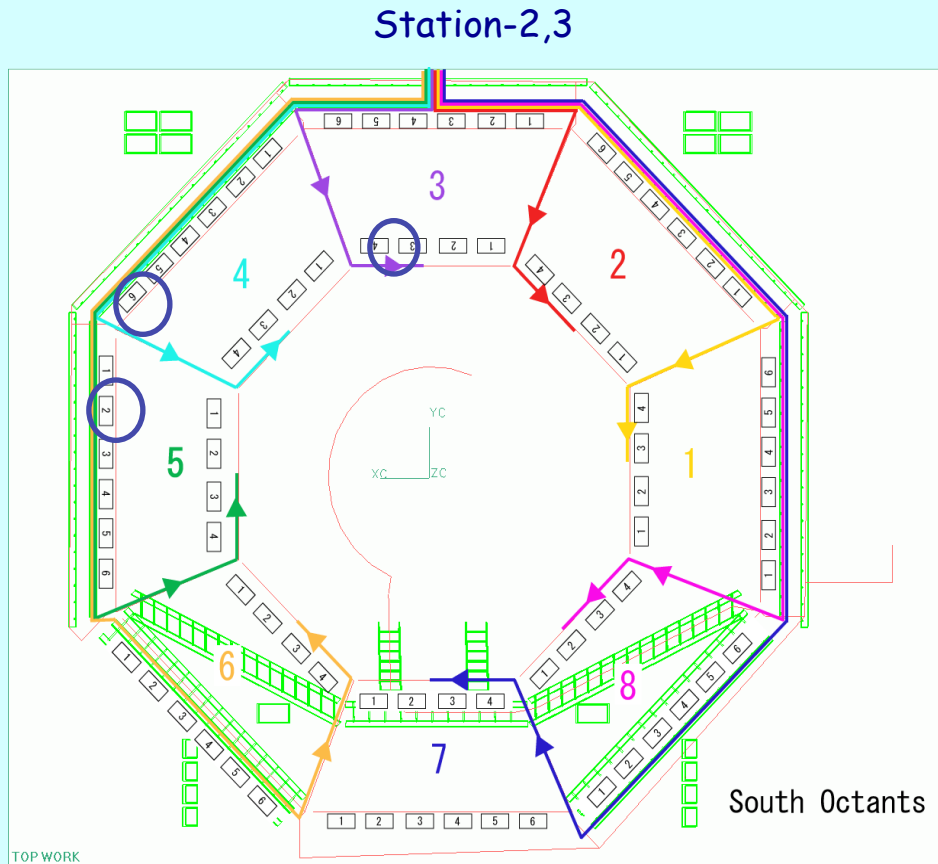
PHENIX SOUTH ARM

MuTr South Arm Areas to be accessed

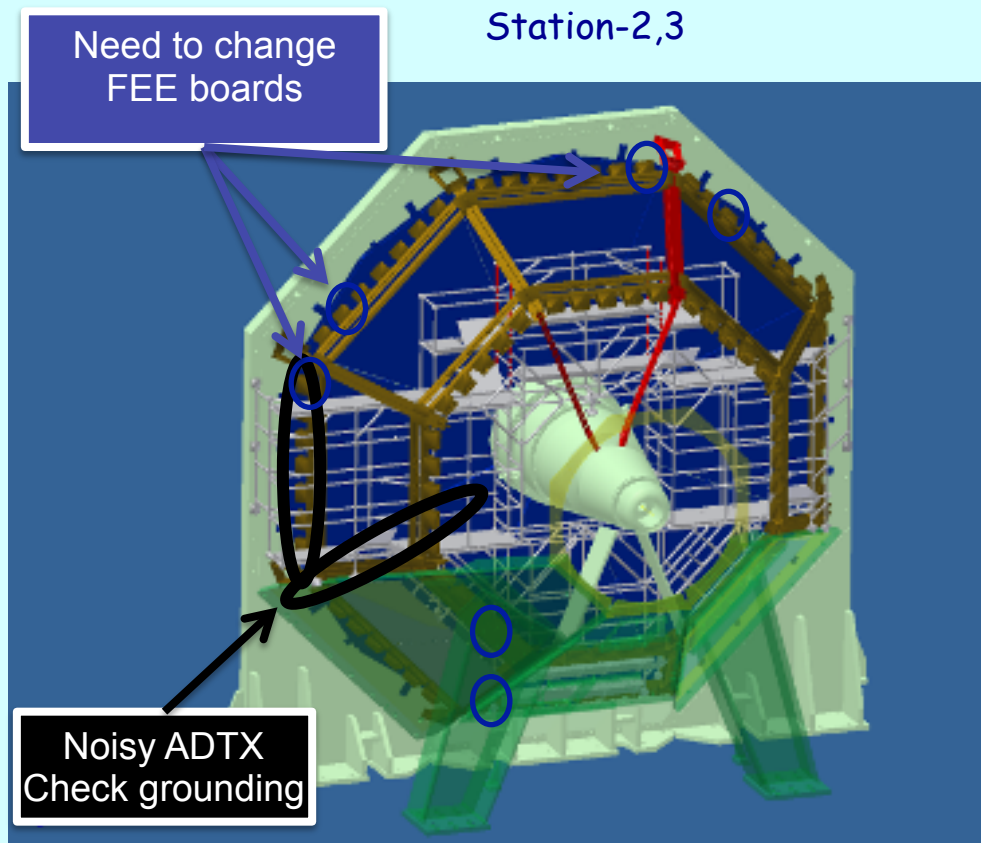
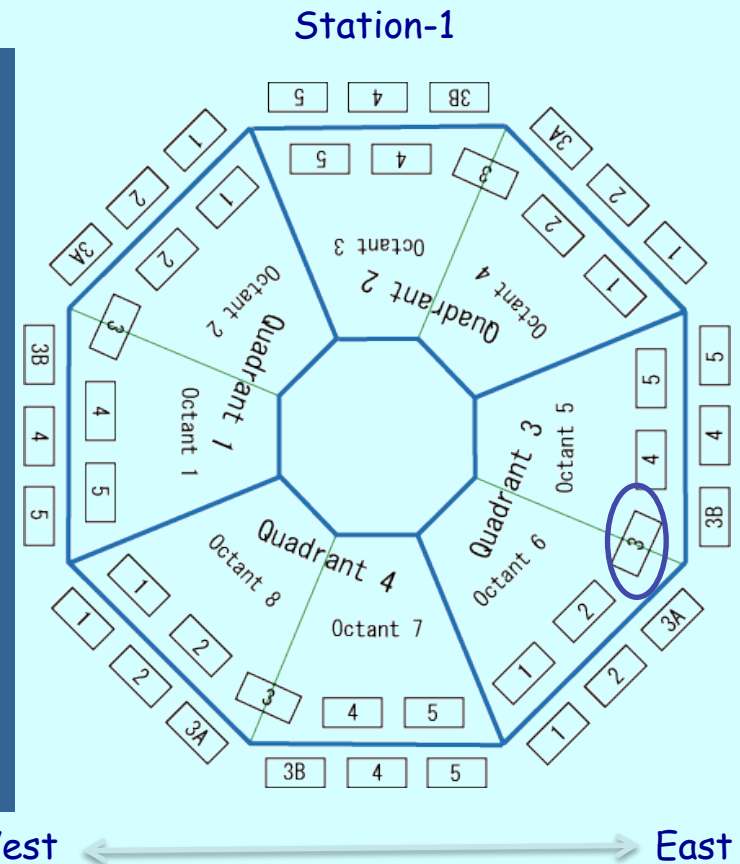
PHENIX NORTH ARM

MuTr North Arm Areas to be accessed

This area will not be accessed during 2013 shutdown.

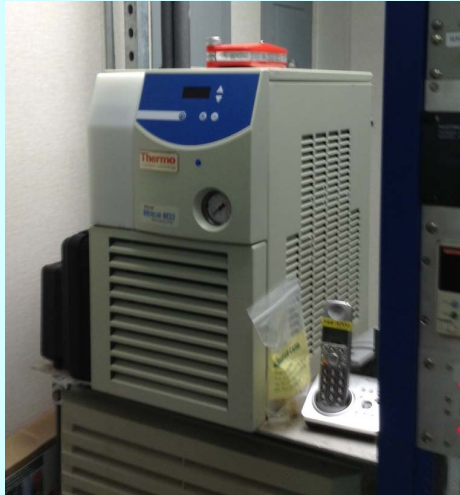
Merlin Chiller

➤ Chiller supplied about ½ the flow as in the past.

- Pressure on chiller says ~70-80psi
- Install gauge on supply line and measure actual output pressure.
- Replace chiller with spare if needed.
- Send old chiller out for maintenance or replace.

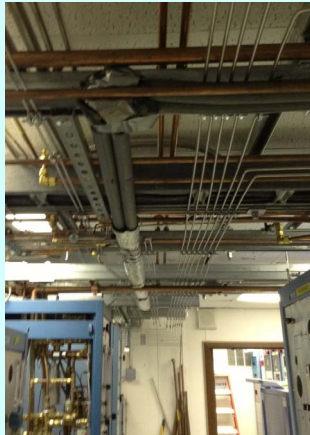
Re-Insulate Glycol lines

❖ Remove old polyethylene insulation and wrap and replace with foam rubber insulation.

- Temp of fluid is affected too much by temp change in the gas house.
- Lines are condensing and dripping because of gaps in insulation.

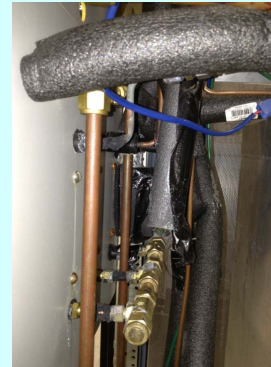
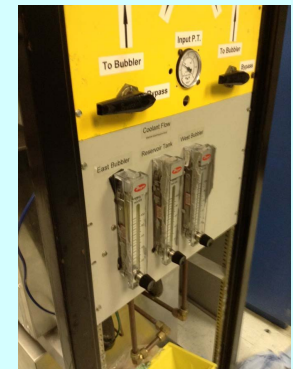
Locate and fix Glycol Leak.

- Replace all three flow meters (compatible with Propylene Glycol)
 - switch to Visi-Float (VFA) for better compatibility
- Redo connections (replace fittings) behind flow meters
 - Re-insulate all cold lines with foam rubber insulation.
